Report No.: 100214617GRR-001b
Page 1 of 5

Access Cover 3rd Party Test Witnessing

**Three (3) GMI 26" glass fiber reinforced
covers with GMI composite frame to
AASHTO M 306-05**

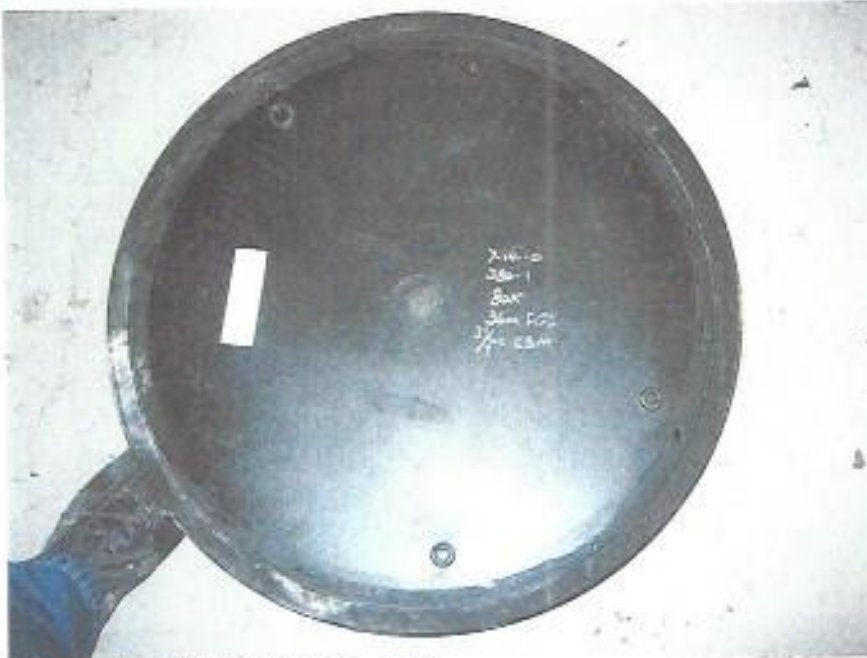
Figure 1 - AASHTO 26 inch #2.

Access cover was loaded within a frame (see Figures 1-2). All loading exposures were applied with a 229 mm x 229 mm (9 inch x 9 inch) steel plate, nominal 1 inch thick with a 1/4" rubber load distribution pad sandwiched between the steel plate and the test sample.

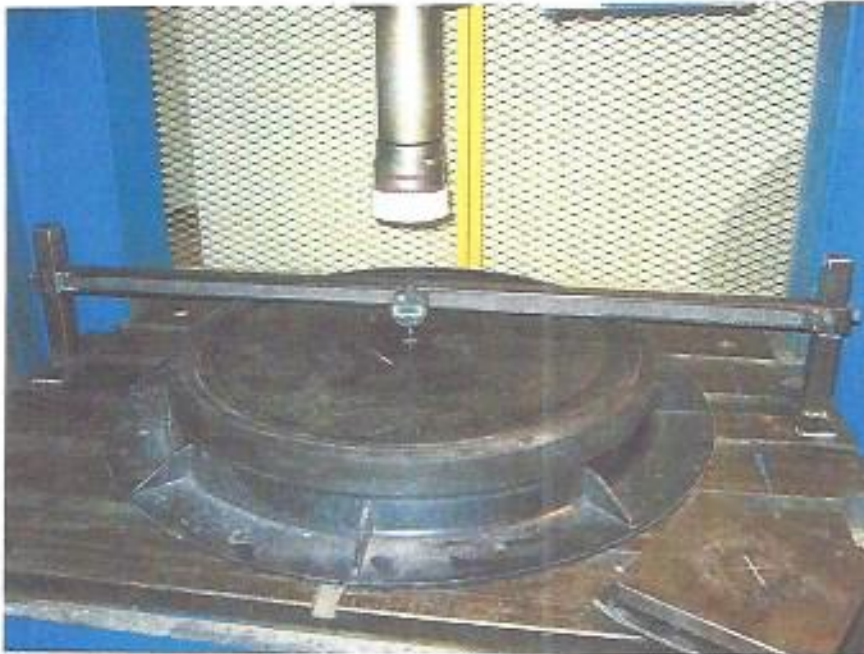
Figure 2 - AASHTO 26 inch zero displacement set.

The permanent displacement measurement was determined via dial indicator attached to a reference frame at the center of the access cover. Gauge was set to 0.000" initially, gauge fixture was removed, cover was loaded and then gauge fixture was re-installed to record a permanent set. Load application rate was a nominal 1 – 5 kN / sec.
