Report No.: 100214617GRR-001d
Page 1 of 5

GMI COMPOSITES

Access Cover 3rd Party Test Witnessing

**Three (3) GMI 26" glass fiber reinforced
covers with GMI composite frame to
EN 124**

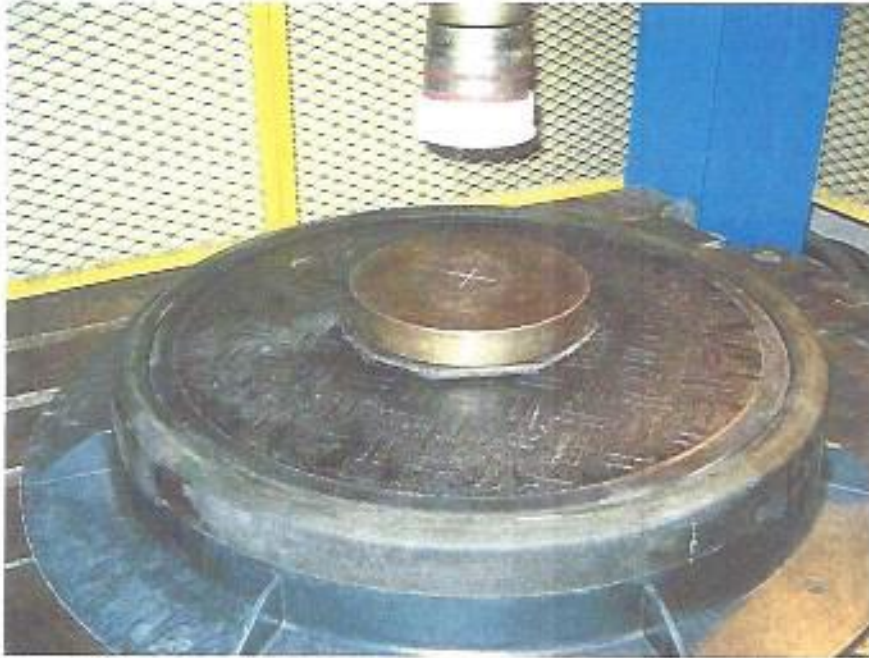
Figure 1 - EN 26 inch load set-up.

Access cover was loaded within a frame (see Figure 1).

All loading exposures were applied with a 250 mm DIA steel disk plate, with a ¼" rubber load distribution pad sandwiched between the steel plate and the test sample.

The permanent displacement measurement was determined via dial indicator attached to a reference frame at the center of the access cover. Gauge was set to 0.000" initially, gauge fixture was removed, cover was loaded and then gauge fixture was re-installed to record a permanent set.
